1979 GLC AIR CONDITIONER

051/79
1/17/79

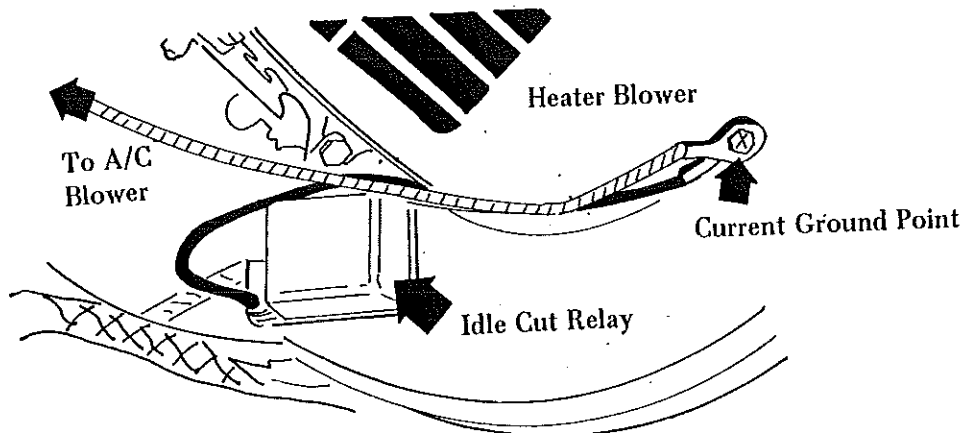
Due to the plastic blower housing on GLC's produced after September 1978, the ground for the air conditioner blower and idle cut relay must be relocated to a blower mounting bolt for proper operation.
