Series 5 Anti-Theft and Flasher CPU Recap and Repair 2024

By ProfessionalPyroman

This guide is written to inform owners on the means to suitably repair the Anti-theft and Flasher CPU in the Series 5 Mazda RX-7. This document may be applicable to additional model series, but the work detailed herein is based on a Series 5 Turbo II CPU. CPU provided by Turbonut, photos and work provided by ProfessionalPyroman.

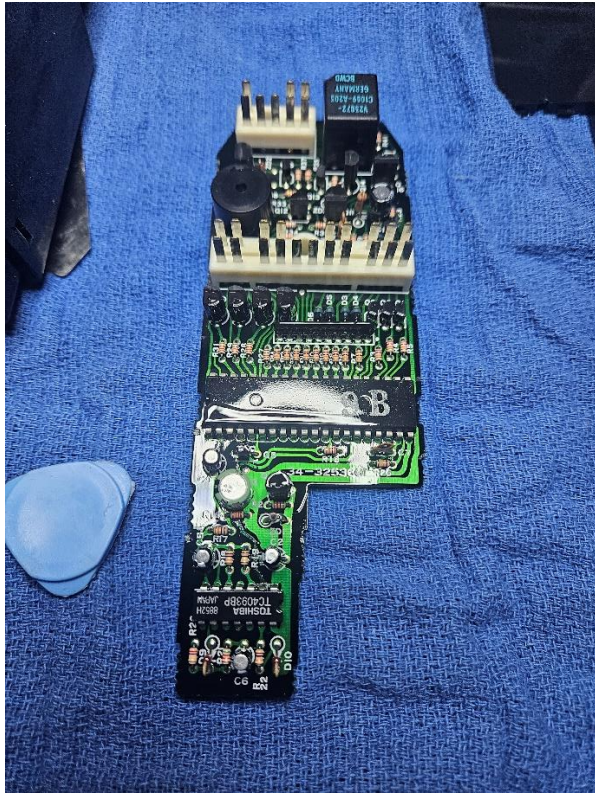
Figure 3 CPU Board

The first board examined is the CPU board. This is where most of the failures have been found by the Author when working on these units. The most common observed failure for these units is failed electrolytic capacitors. The capacitors leak over time, or all at once, spreading corrosive electrolyte across the printed circuit board. This failure has been present at varying degrees in all of the units that the Author has worked on.

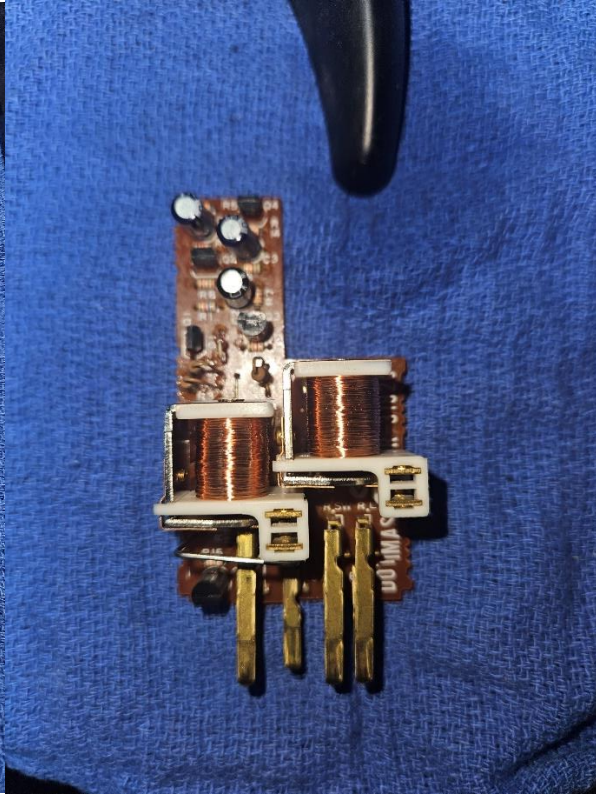
Figure 4 Flasher Relay Board

The flasher relay board, shown in Figure 4, is a simple design. The circuit board is only printed on the bottom side. It is possible that by having the printed circuits on the bottom, this inhibits corrosion from becoming as bad as that found on the double-sided CPU circuit boards. The Author has found failed capacitors on flasher boards, but no noticeable corrosion. There are only three electrolytic capacitors to replace on this board, shown in Figure 11. Replacement is fairly straightforward, with the only standout being that C2 is a bi-polar capacitor. If this is replaced with a regular electrolytic capacitor, it will adversely affect the function of the hazards and turn signals.

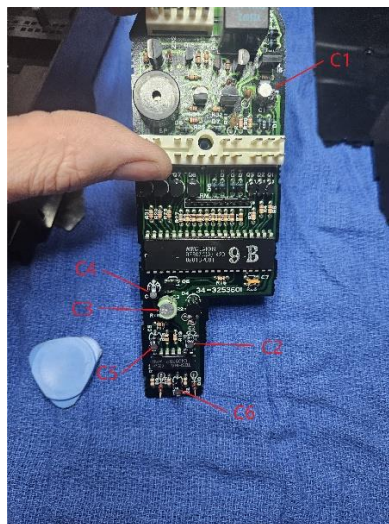
Figure 5 Electrolytic Capacitor Locations

There are six electrolytic capacitors on the CPU board, labeled C1-C6 (Figure 5). C7 is ceramic and does not present a risk of failure. A list of capacitor values is included at the end of this document. The first problem area is capacitor C1 and its surrounding components. This is the main power filter capacitor. It takes 12v power from the battery and filters it for the 5v regulator and other components. This area of the circuit board has been damaged in every unit that the Author has worked on. This area was also the main focus of the repair on this unit.

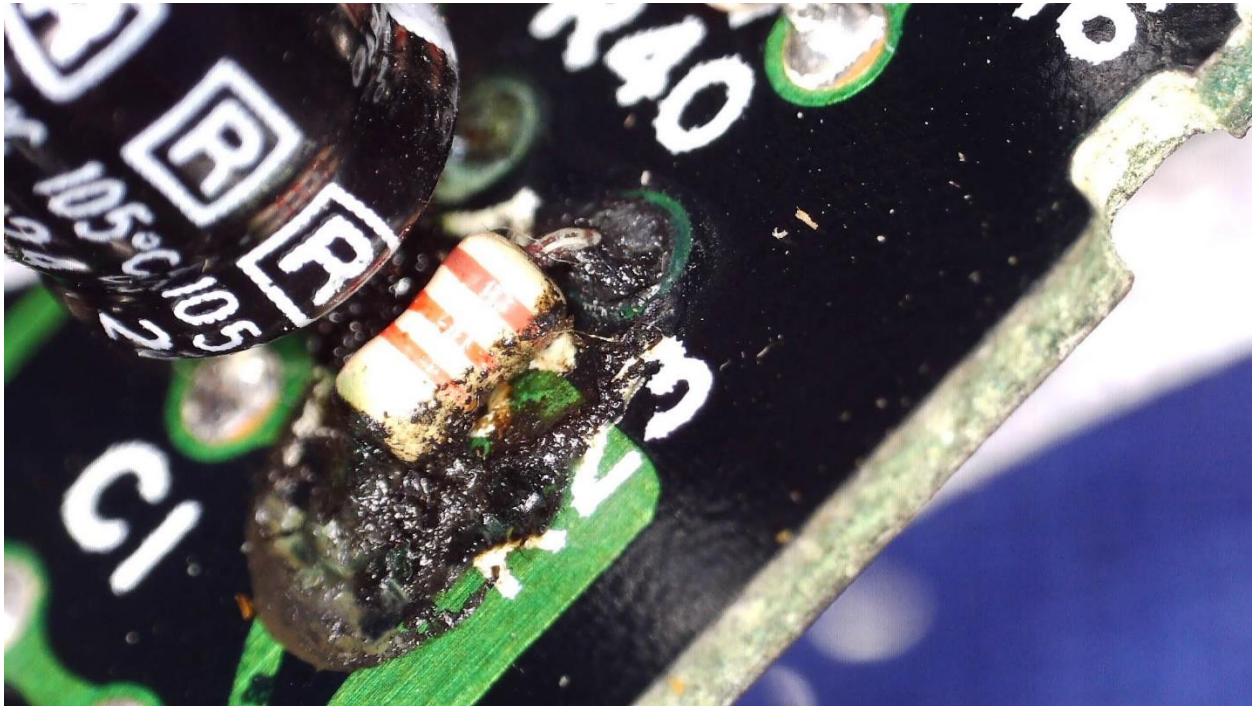
Figure 6 Failed C1 Capacitor and Corroded R23

Figure 6 shows a zoomed in view of the afflicted area. In the case of this CPU C1 failed, which by itself would not cause the unit to cease function but damage to the circuit board also contributed to the overall failure of the unit. C1 was desoldered and removed from the board to assess the damage to the underlying circuits, shown in Figure 7. In Figure 7, the damage to the underlying circuit board is easily shown. Where there was originally a solid copper trace under C1, a large corroded pit can be found. The copper from that portion of the trace was eaten away by the leaked electrolyte. In addition, substantial corrosion covered R23 enough that the resistor was eaten into two parts and crumbled upon removal. The area was cleaned and the traces tested for continuity, shown in Figure 8.

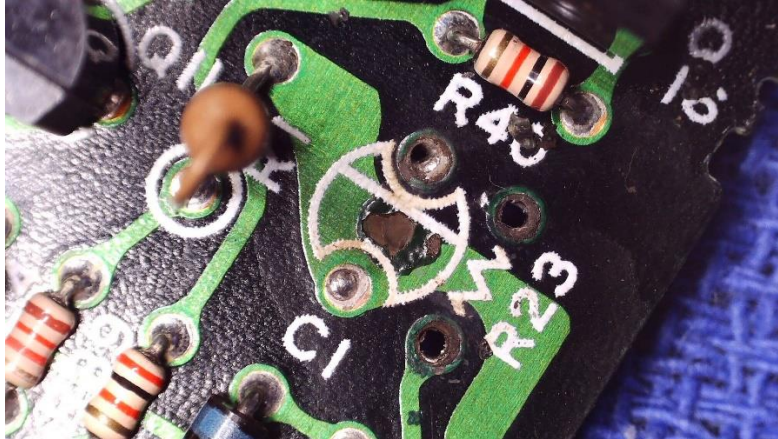
Figure 8 Damaged C1 and R23 Traces

The damage in this case was manageable. There was enough of the large trace left that battery voltage could pass from R1 to the 5v regulator easily. There was damage on the plated thru-holes for C1 and R23. This was not a concern for component C1 as the upper hole, near R40 does not connect to this side of the circuit board, but the ground plane on the back side of the board. The same is true for the upper hole on R23. There was additional work needed on R23 however. The lower PTH was corroded enough that a connection could not be made with the harness pin connector. This resistor is responsible for draining voltage away from the pin when the key is removed from the ignition cylinder. The Author suspects that the severing of this trace by corrosion is what causes the car alarm to go off upon CPU failure because the microcontroller may view this event as a car alarm trigger. More testing will be needed to confirm this.

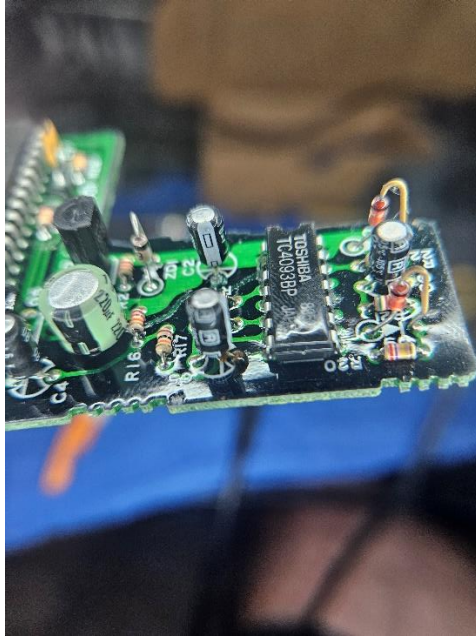
Figure 10 C2-C6 Leakage and Corrosion

This was the repair for the C1 area. C2, near the 5v regulator was the next capacitor to be replaced. It had also leaked and was corroding a nearby trace, shown in Figure 10.

In Figure 10, capacitors C2-C6 can be seen, as well as a darker trace next to C2 running from the Toshiba NAND trigger package to the NEC uPD7507 microcontroller. C2 had leaked similar to C1 and was starting to corrode this trace as well. After removal of C2-C6, the corroded traces were inspected and still found to be intact. If the damage worsens, jumper wires will be used here as well. With all the electrolytic capacitors replaced on this board, and connections verified, it was secured back inside the CPU case, and the flasher relay board was inspected.
