## Issue with Rebuilt Engine w/ Pics

Kevin, the other weekend we were replacing the turbos on the 93-95 longblock that I bought from you. We ended up taking the exhaust manifold off too. It was then that we discovered that both exhaust port sleeves had holes melted in them! No one I've talked to had ever seen this before. At first, we weren't sure if the holes belonged there or not, so we looked it up online and discovered that some of the melt pattern corresponded with where a diffuser used to be on a NA housing/exhaust sleeve. Cutting the exhaust diffuser out of the sleeve would have left rough/sharp edges as you know. Rough/sharp edges would have become super heated by the exhaust flow with respect to the rest of the sleeve. This edge would have been much more likely to ignite the unburned fuel in the exhaust - further increasing the exhaust temperature and leading to a glowing down pipe. Additionally, the sharp edge would have begun melting sooner than the rest of the sleeve. Once it began melting, it probably would have spread until a hole was melted through. Furthermore, if Mazda coated the exhaust sleeve with some other composite, cutting the diffuser out would have damaged

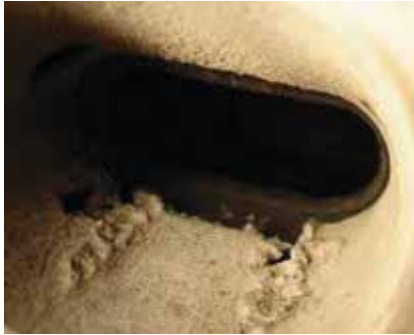
**13B\_Exhaust\_Port\_030.jpg**  
213K

I wasn't sure if the glowing was the chicken or the egg. But my main concern now is the remaining metal that didn't melt. The metal protrusions that remain are bendable by hand. It could fall off and get sucked into the engine or fall off and take my expensive turbos out on their way out. The sharp metal CAUSING the glowing is only a secondary concern and just a possibility.
