Compatibility of Tubing Material with Hot Engine Oil

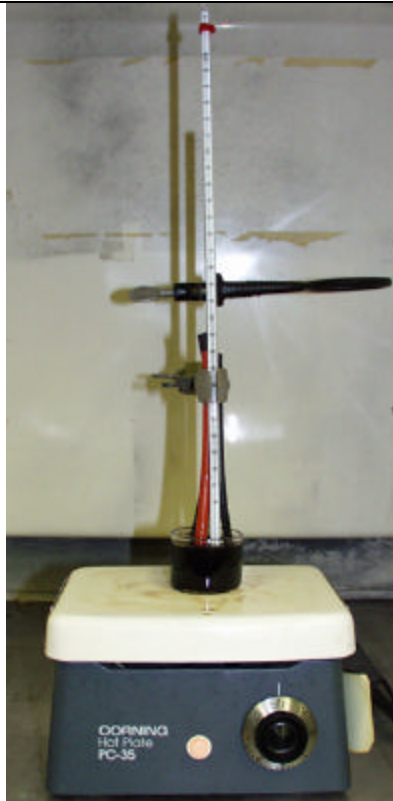
Figure 1. The test setup consisted of the three tubes suspended vertically. Approximately two inches of the tubing was immersed in the 30W-engine oil. The oil temperature was maintained at 240 °F for 1,000 hours.

The experiment is rather simple. Figure 1 is a picture of the test setup. I placed three hoses made from silicone, Viton and Neoprene in oil maintained at 240 °F for 1,000 hours. This is not exactly the conditions a hose under the hood of a third generation RX-7 experiences, but since the Neoprene is similar to the OEM hose material I used it as a control. I checked the condition of the tubing every 200 hours. I stopped the experiment when the Neoprene tubing was in the same condition as many of the six-year-old OEM hoses on my RX-7.

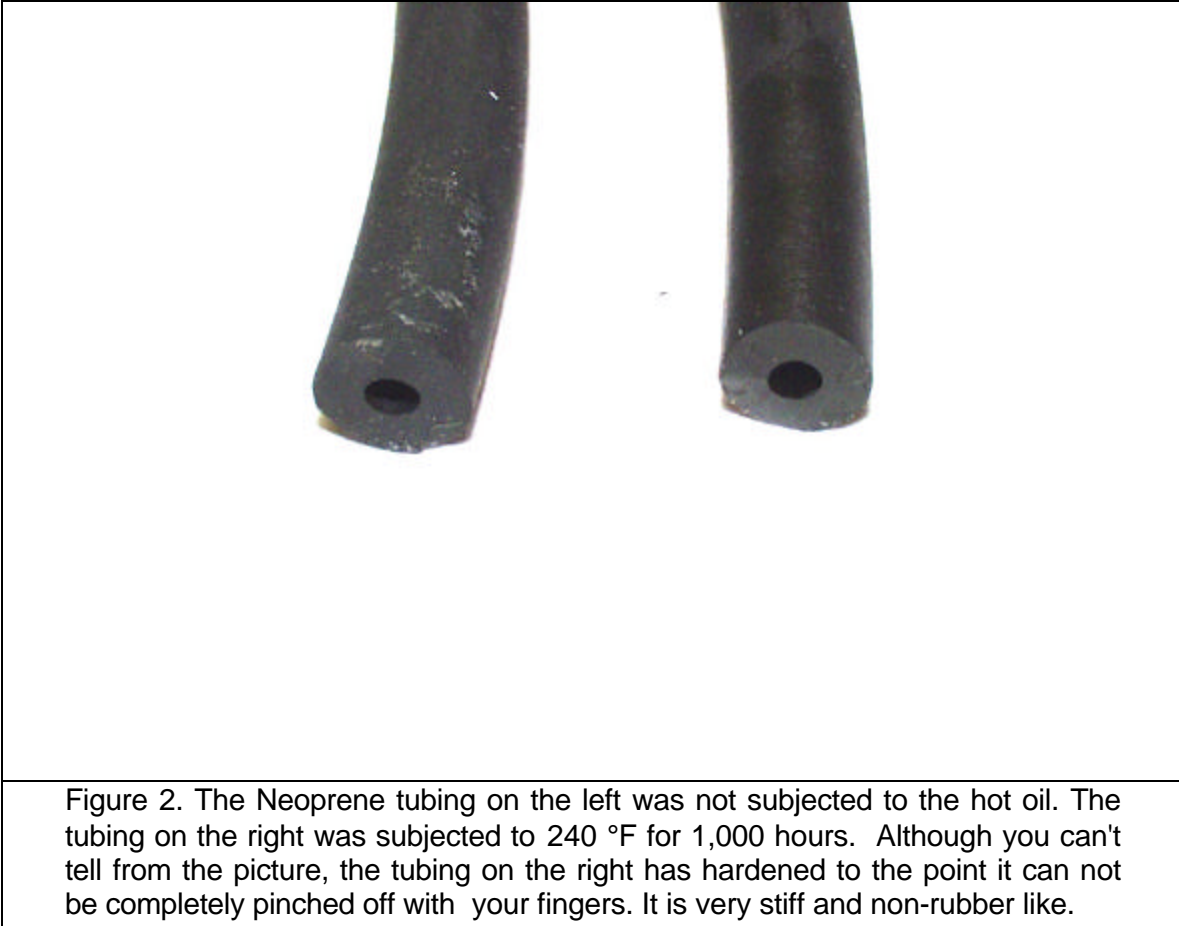
Figure 2. The Neoprene tubing on the left was not subjected to the hot oil. The tubing on the right was subjected to 240 °F for 1,000 hours. Although you can't tell from the picture, the tubing on the right has hardened to the point it can not be completely pinched off with your fingers. It is very stiff and non-rubber like.

This is similar to the OEM tubing material. After the test, it was in similar condition that many of the original vacuum hoses are in after 60,000+ miles (Figure 2). The rubber has lost all of its elasticity and was very hard and stiff. Squeezing it firmly between my thumb and forefinger I could not completely pinch off the tubing. The OEM tubing typically fails because it hardens and no longer forms a seal with the fittings and begins to leak. The Neoprene tubing would most likely fail in a similar manner.

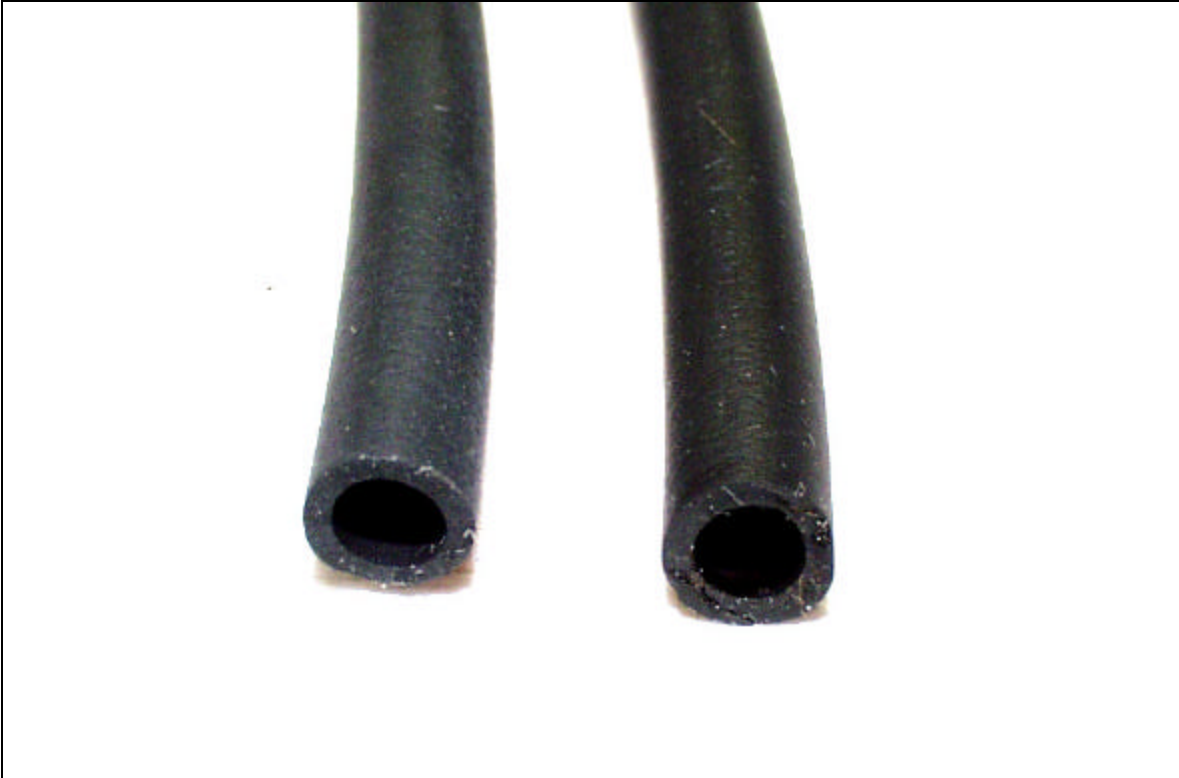
Figure 3. The Viton tubing on the left was not subjected to the hot oil. The tubing on the right was subjected to 240 °F for 1,000 hours. Other than a film of oil coating the surface there is no difference between the tubes. The elasticity, hardness and strength were not degraded.

Except for the oil film you could not tell the tested tubing from brand new tubing. There was no discoloration or swelling, the elasticity and strength was the same. This was a surprise to me, the specifications indicated that Viton was good, but I had expected some degradation in this test.

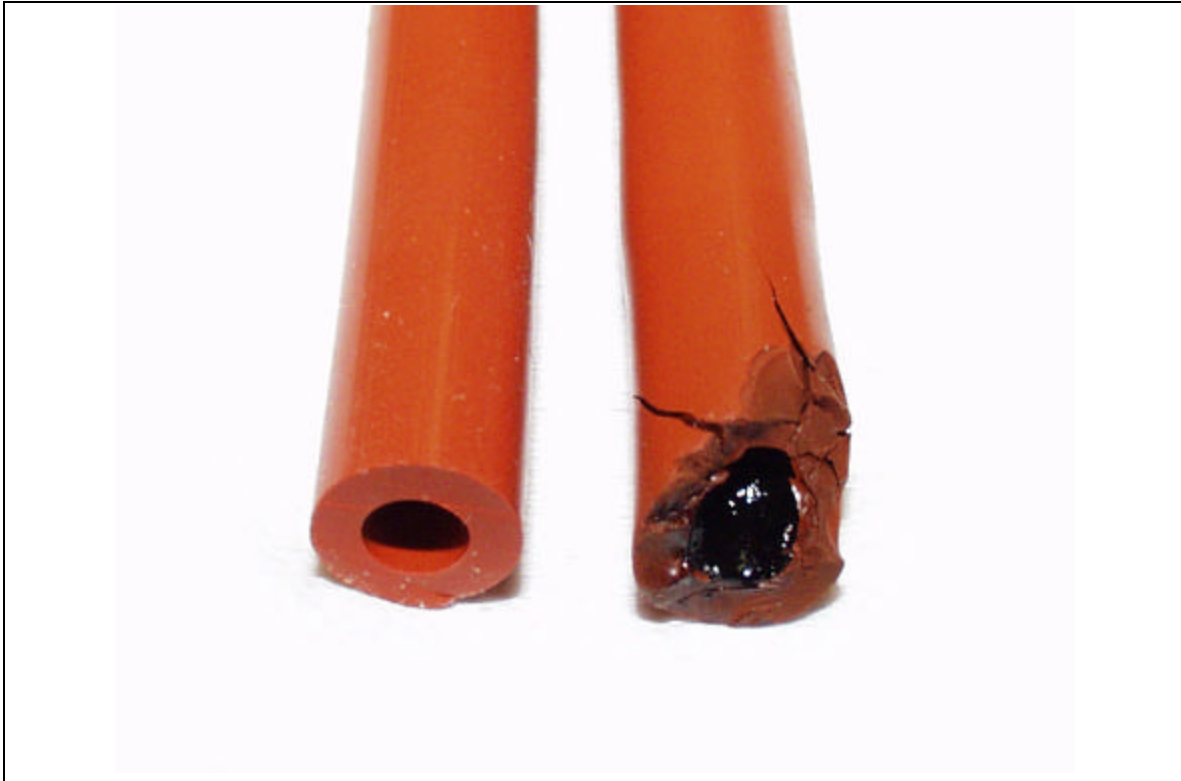
Figure 4. The silicone tubing on the left was not subjected to the hot oil. The tubing on the right was subjected to 240 °F for 1,000 hours. The tubing on the right has lost its structural integrity. It has swollen and split. It will break into small chunks if you try to pinch the tube end. The black substance inside the tube appears to be congealed oil possibly from a reaction of the oil with the silicone elastomer. This jelly like substance was not present inside the Viton or Neoprene tubing.

The silicone tubing had lost much of its structural integrity. It had swollen and split while immersed in the oil. When I squeezed it between my thumb and forefinger it crumbled into small chunks. It had not hardened like the Neoprene but it could be easily pulled apart with my fingers. Splitting from the ends, as seen in Figure 4, has been reported as the main failure mode of silicone tubing, heat and oil appear to rapidly accelerate this tendency.

The best material for vacuum hoses on the third generation RX-7 is Viton tubing. Based on this test, silicone does not appear to offer much of an advantage in longevity over Neoprene tubing. The main difference is the failure mode. Silicone will remain pliable until its structural strength is compromised. This may be of some advantage. Hardened neoprene tubing, which has lost its elasticity, will not form a good seal where it is connected to a fitting. This failure mode is very hard to visually diagnose. The silicone tubing will probably lose its structural integrity and split. You can see from Figure 4 that this would be easier to visually diagnose.
