VEHICLE DETAILS

Chassis number ¹: FD3S-204457

Model: EFINI RX-7

PHOTOS AND AUCTION SHEETS

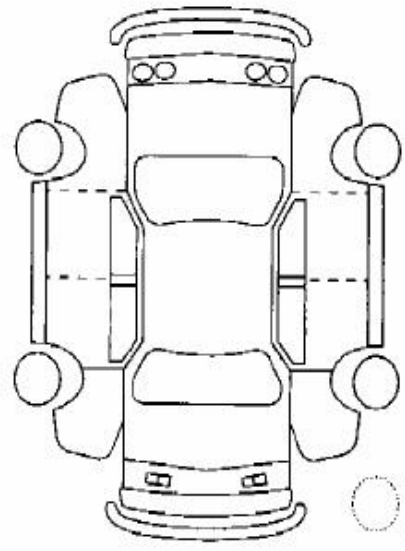
車体NO FD3S-204457

検査員記入 FW A・X要ス 室内シート コゲ・穴・汚れ・キズ・破れ

エンジンから現状車

フロントハブ コアサボット)XX

小キズ有・小凹有

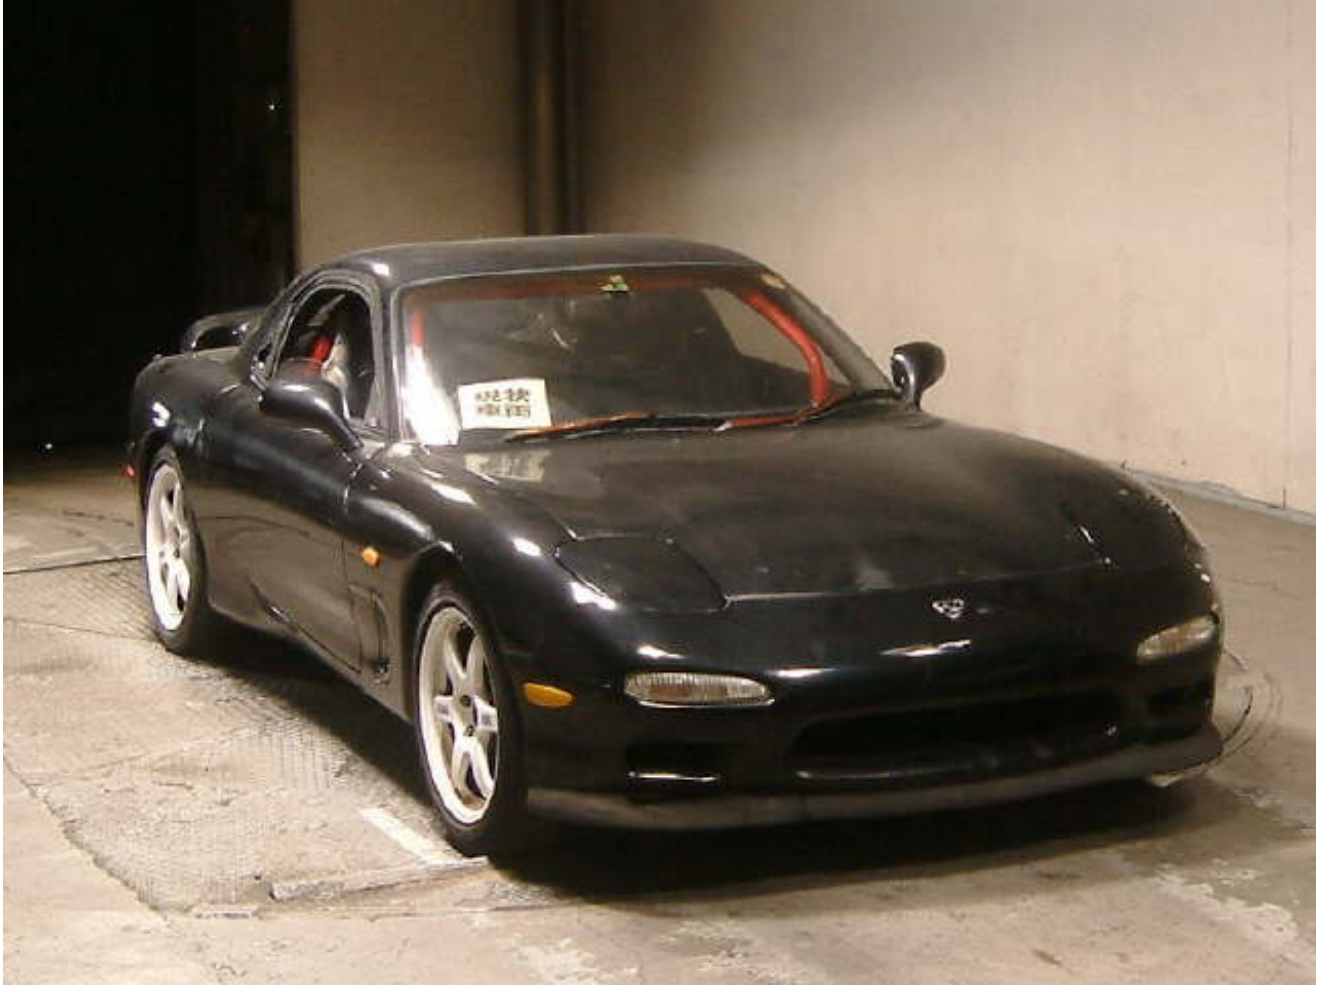
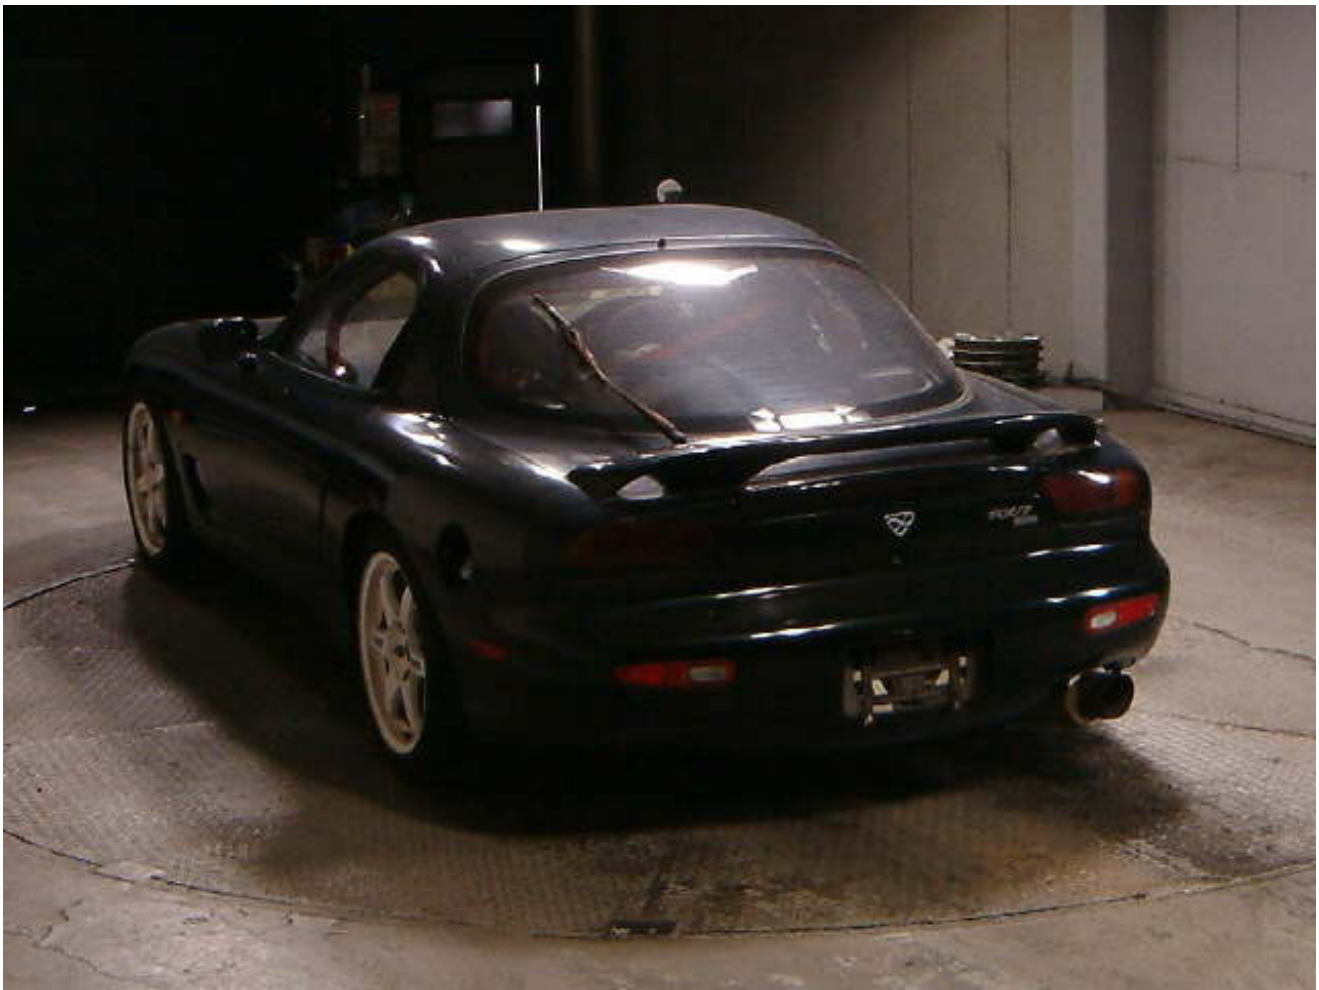
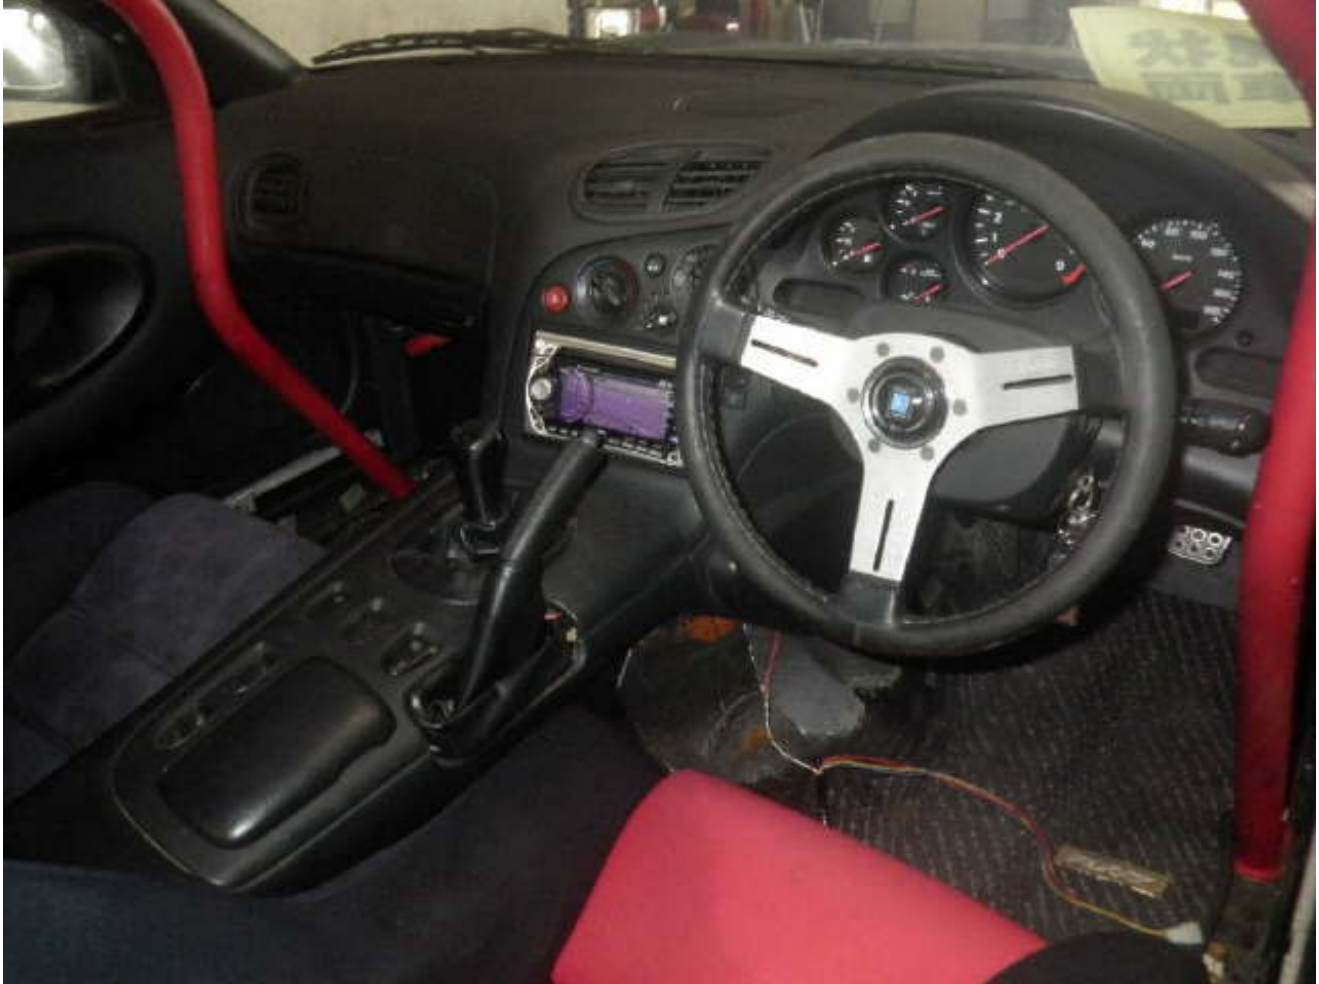
出品番号 70008	型式 E-FD3S	排気量 RE CC	車歴 自家用・レンタ・()	評価点 R
	初年度登録 6/8月	車名 RX-7 3 HB	ドア形状 717°R	グレード 2WD 4WD
車検	年	月	燃料 G・D・ハイブリッド・()	定員 ()人
				積載量 kg

名変期限	月	日迄
出品店記入 (注意事項)	外装・7 (R-777) マフラー TE37 17インチ AW、D席外シート ロールオーバー、外ハンドル	
検査員記入	内装	シート
	ウス汚れ・汚れ・コゲ キズ スレ コゲ 穴 キレ シミ ナシ 穴	
	コアサポート ×× BP 足み	FE 2 パネ BP 足み
		F サイト × パネ BP 足み
入	カーナビ	オイル もれ
		タビ 変形

ホイール	ドアミラー	小キズ	小ヘコミ
キズ ワレ	キズ ヒビ ワレ	(有)	(有)
