Compatibility of Tubing Material with Hot Engine Oil

The Problem

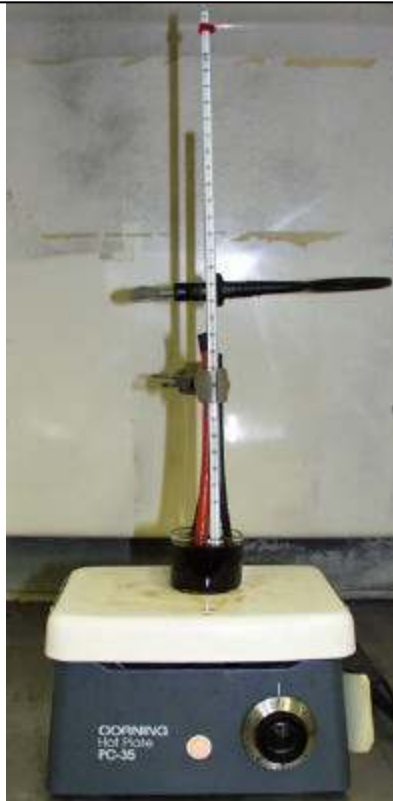
Figure 1. The test setup consisted of the three tubes suspended vertically. Approximately two inches of the tubing was immersed in the 30W-engine oil. The oil temperature was maintained at 240 °F for 1,000 hours.

The experiment is rather simple. Figure 1 is a picture of the test setup. I placed three hoses made from silicone, Viton and Neoprene in oil maintained at 240 °F for 1,000 hours. This is not exactly the conditions a hose under the hood of a third generation RX-7 experiences, but since the Neoprene is similar to the OEM hose material I used it as a control. I checked the condition of the tubing every 200 hours. I stopped the experiment when the Neoprene tubing was in the same condition as many of the six-year-old OEM hoses on my RX-7.

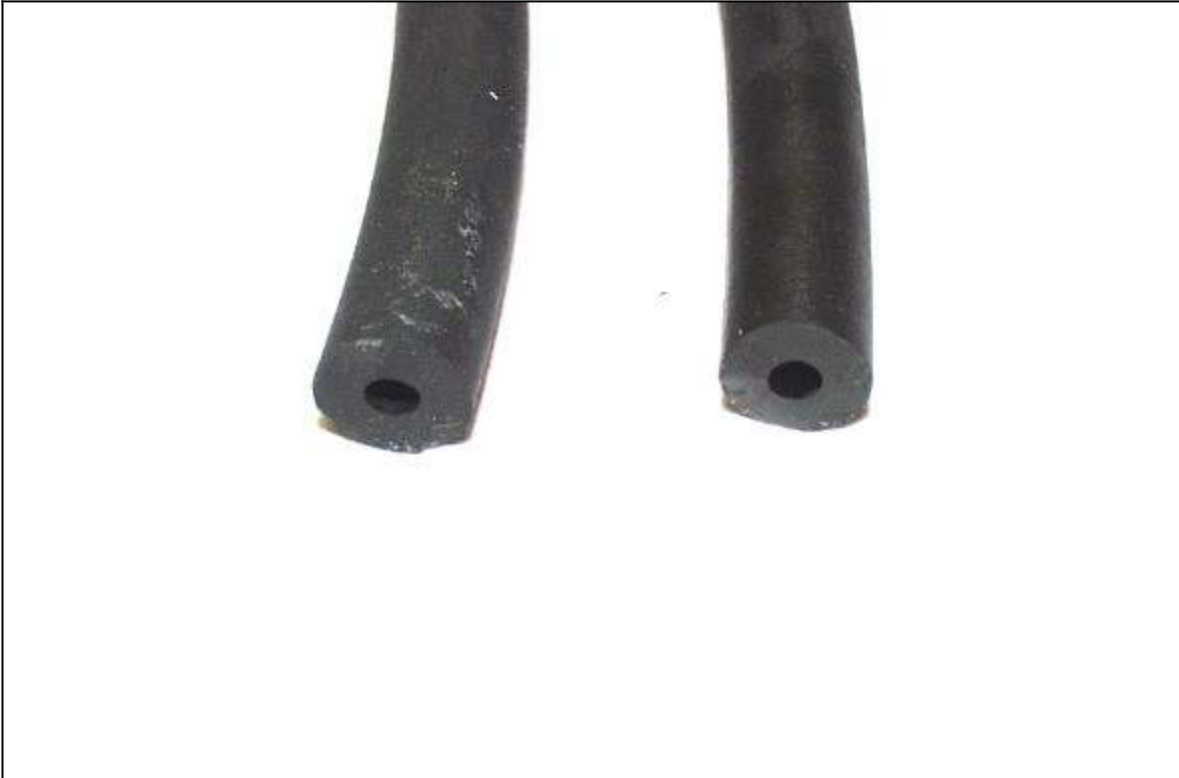
Figure 2. The Neoprene tubing on the left was not subjected to the hot oil. The tubing on the right was subjected to 240 °F for 1,000 hours. Although you can't tell from the picture, the tubing on the right has hardened to the point it can not be completely pinched off with your fingers. It is very stiff and non-rubber like.

This is similar to the OEM tubing material. After the test, it was in similar condition that many of the original vacuum hoses are in after 60,000+ miles (Figure 2). The rubber has lost all of its elasticity and was very hard and stiff. Squeezing it firmly between my thumb and forefinger I could not completely pinch off the tubing. The OEM tubing typically fails because it hardens and no longer forms a seal with the fittings and begins to leak. The Neoprene tubing would most likely fail in a similar manner.

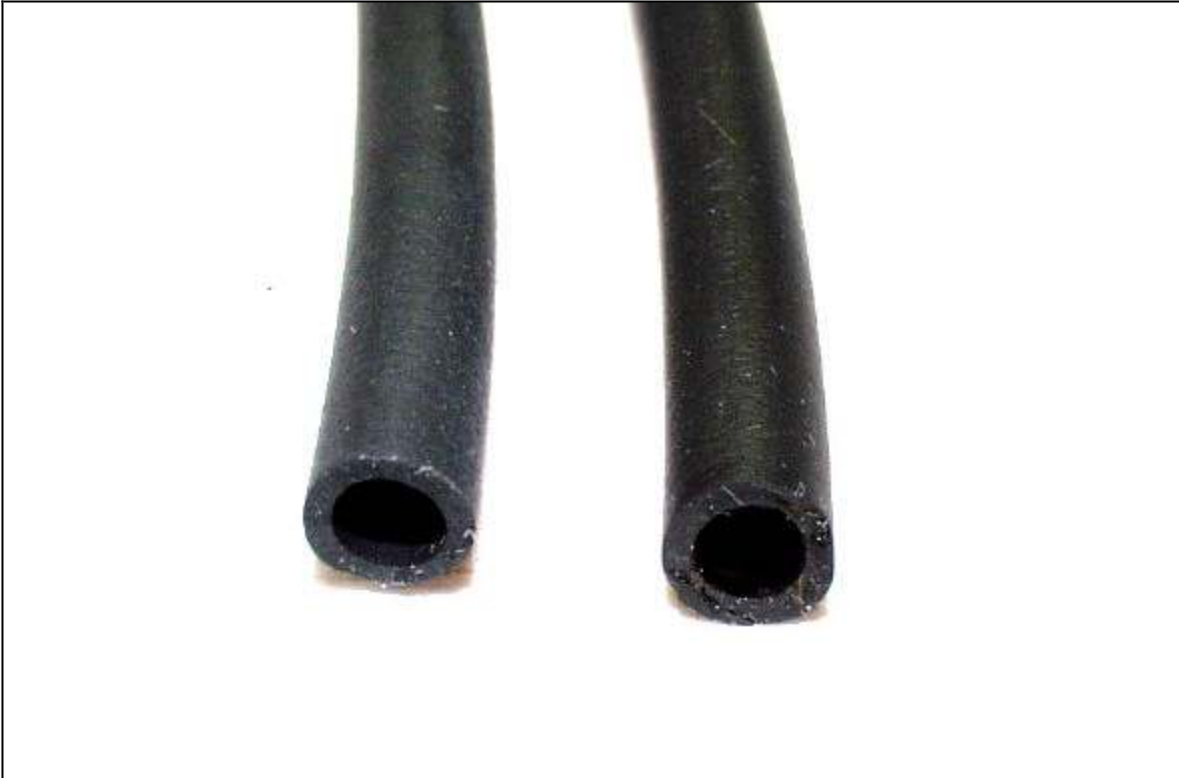
Figure 3. The Viton tubing on the left was not subjected to the hot oil. The tubing on the right was subjected to 240 °F for 1,000 hours. Other than a film of oil coating the surface there is no difference between the tubes. The elasticity, hardness and strength were not degraded.

Except for the oil film you could not tell the tested tubing from brand new tubing. There was no discoloration or swelling, the elasticity and strength was the same. This was a surprise to me, the specifications indicated that Viton was good, but I had expected some degradation in this test.

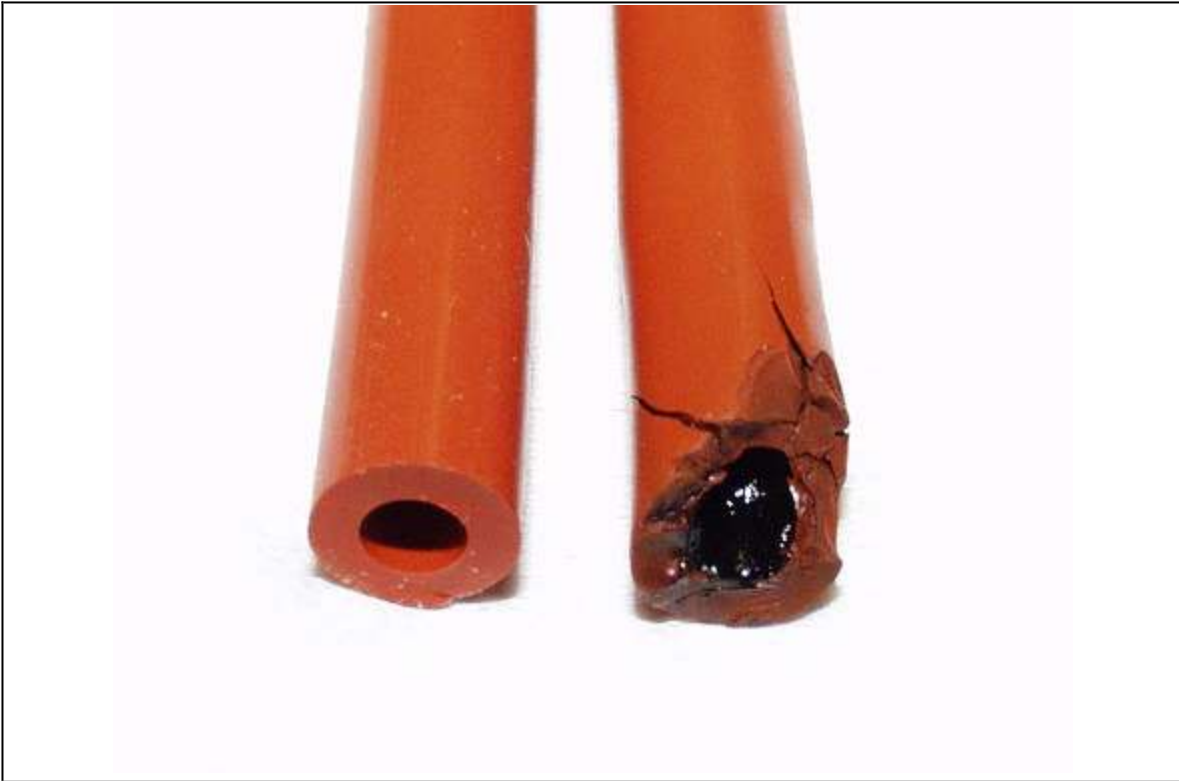
Figure 4. The silicone tubing on the left was not subjected to the hot oil. The tubing on the right was subjected to 240 °F for 1,000 hours. The tubing on the right has lost its structural integrity. It has swollen and split. It will break into small chunks if you try to pinch the tube end. The black substance inside the tube appears to be congealed oil possibly from a reaction of the oil with the silicone elastomer. This jelly like substance was not present inside the Viton or Neoprene tubing.

The silicone tubing had lost much of its structural integrity. It had swollen and split while immersed in the oil. When I squeezed it between my thumb and forefinger it crumbled into small chunks. It had not hardened like the Neoprene but it could be easily pulled apart with my fingers. Splitting from the ends, as seen in Figure 4, has been reported as the main failure mode of silicone tubing, heat and oil appear to rapidly accelerate this tendency.

The best material for vacuum hoses on the third generation RX-7 is Viton tubing. Based on this test, silicone does not appear to offer much of an advantage in longevity over Neoprene tubing. The main difference is the failure mode. Silicone will remain pliable until its structural strength is compromised. This may be of some advantage. Hardened neoprene tubing, which has lost its elasticity, will not form a good seal where it is connected to a fitting. This failure mode is very hard to visually diagnose. The silicone tubing will probably lose its structural integrity and split. You can see from Figure 4 that this would be easier to visually diagnose.
