Service Bulletin

Category 3	Applicable Model/s 1986-1987 RX-7	Subject COOLANT LOSS	Bulletin No. 007/87
			Issued 6/3/87
			Revised

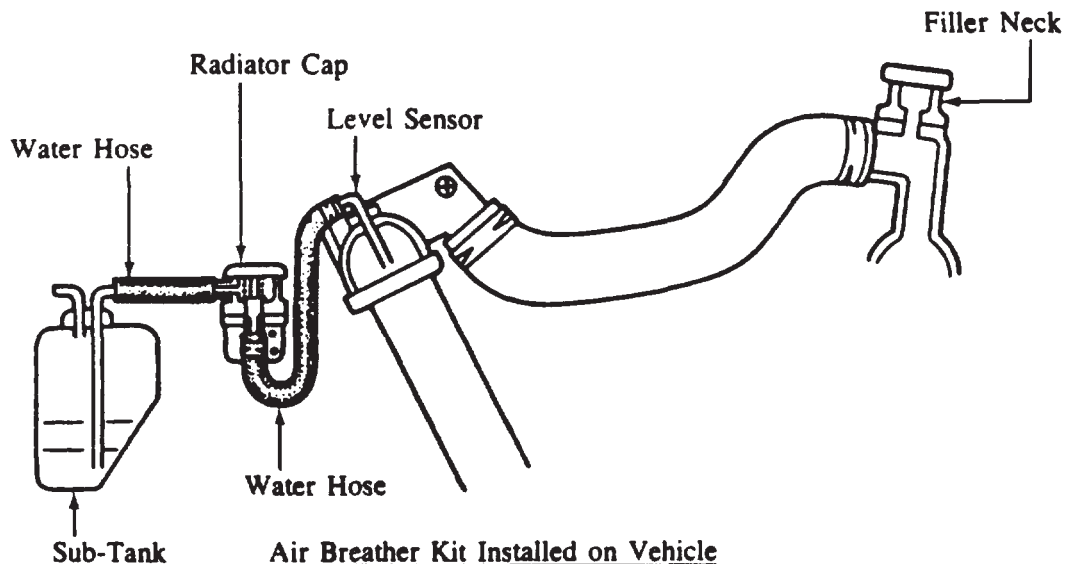
Check to determine if a radiator cap is installed near the sub-tank as shown below. If not, install the air breather kit. Refer to Service Bulletin Category 3, 005/87 for repair procedure and warranty information.

To help prevent coolant loss in the 1986-1987 RX-7, Mazda has developed an air breather kit for the radiator as described in Service Bulletin Category 3, 005/87.

In order to prevent coolant loss and subsequent engine damage, you are requested to install the air breather kit on ALL RX-7 vehicles within the VIN range listed below. This work is to be performed whenever an RX-7 vehicle is brought to your service shop for scheduled or unscheduled service.
